# Case Study – Corrosion Djinn

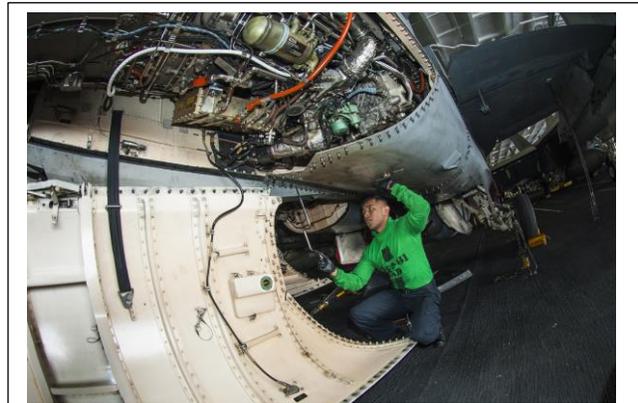
Figure 2 84-day corrosion inspection on an F/A-18E Super

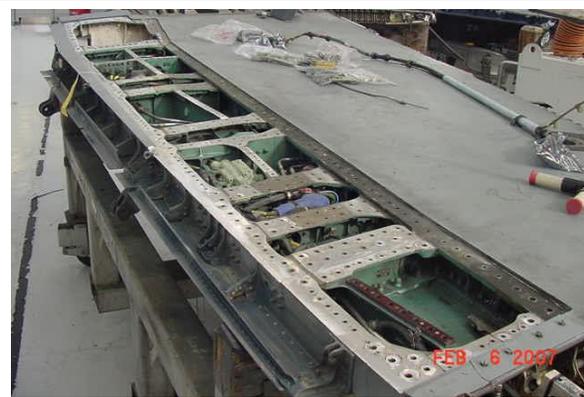
Figure 3 Corrosion under F/A-18F wing panels

There are many corrosion mechanisms, but evidence from aircraft teardowns<sup>3</sup> shows that 80% of corrosion costs related to structural damage stem from galvanic corrosion events. One particular issue is galvanic corrosion around fastener holes, a problem prevalent on the F/A-18F Super Hornet. The current fix for corrosion around fastener holes is to remove the corrosion and bring the hole dimension back into tolerance by opening it up and inserting a bushing. This is a lengthy and costly process,

since even a single wing often has hundreds of corroded holes (Figure 3). The bushing material usually used is a stainless steel such as 15-5PH, because it is widely available in depots and easy to machine. Besides, when the depot maintainer consults the standard reference specification galvanic corrosion,

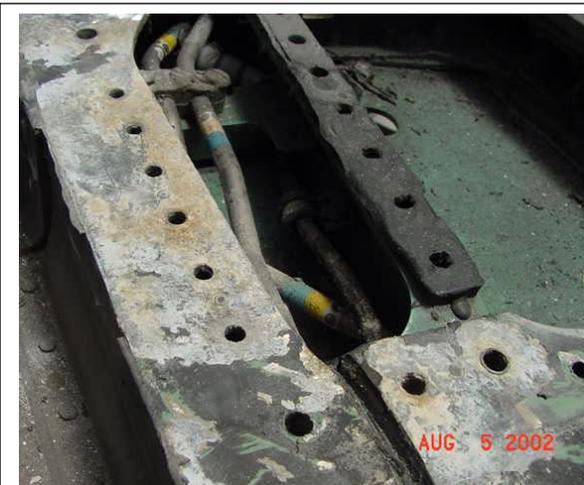
Figure 4 Close-up of corrosion under F/A-18F wing panels
